OIL PUMP REPLACEMENT

THIS INFORMATION IS FOR THE FORD DURATORQ COMMON RAIL ENGINE FROM 2000 - 2006, FITTING 2.0^{CC}, 2.2^{CC} AND 2.4^{CC}

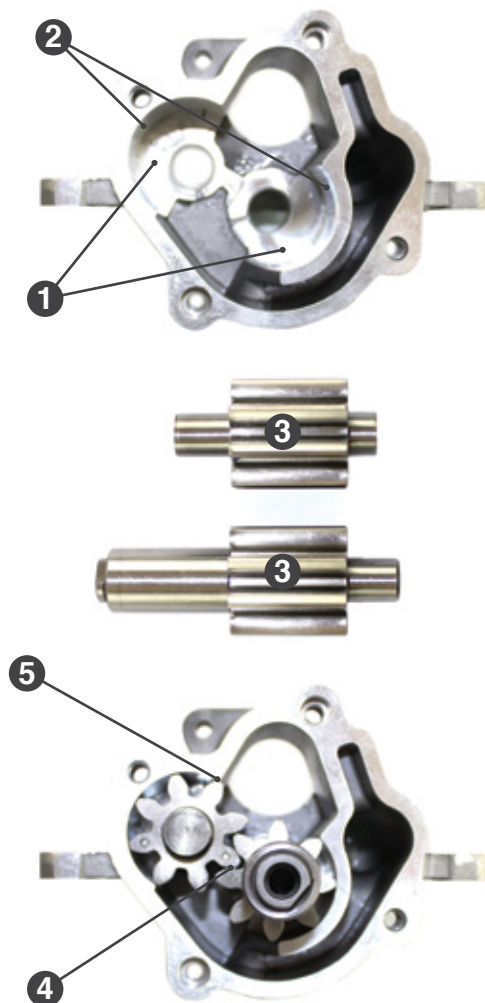
Examination areas and operation

- Low oil pressure warning.
- Turbocharger failure.
- Hydraulic Lifter failure or excessive engine knocking.
- Noise during operating temperature.
- Timing system noise during deceleration.
- Timing failure.
- Poor performance or fuel economy.
- Evidence of oil starvation such as Camshaft damage or bearing journal scoring.
- Irregular service or oil contamination due to excessive levels of hydrocarbon in the Oil Sump Pan filter.

- If hydrocarbon contamination from the combustion cycles are not controlled by regular oil changes an abrasive paste is developed.
- Use of the wrong oil can also cause an abrasive paste which is deposited at the bottom of the Sump Pan. This can work its way through the Oil Pump reducing efficiency and pressure. This may then lead to oil starvation of the bearing journals and Hydraulic systems, causing Timing failure.

DIAGRAM	TEST AREA	TEST TYPE	TOLERANCE	EXAMINE FOR
1	Upper and lower thrust control faces	Surface finish	0.220 > 0.400µm	Wear and scoring
2	Main rotor pressure control faces	Surface finish	0.350 > 0.700µm	Wear and scoring
3	Rotor tooth	Surface finish	0.300 > 0.600µm	Wear and scoring
4	Rotor tooth	Backlash	0.07 > 0.12mm	Wear and scoring
5	Rotor to control face	Clearance gap	0.03 > 0.05mm	Wear and scoring

- Use a surface roughness test and narrow nose feeler gauge to confirm tolerances.
- If results are outside the stated tolerances, displaying evidence of oil starvation, contamination damage or excessive wear, replace the Oil Pump.
- If unsure, replace.
