TB0140K INSTALLATION

Tensioner BC0140-1 in VAG 1.4/1.6 16V

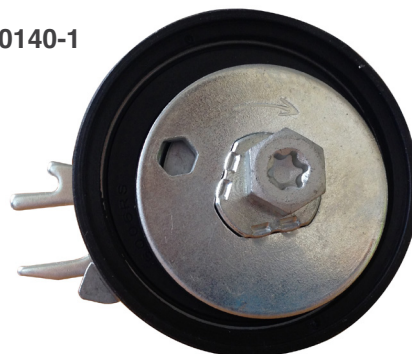
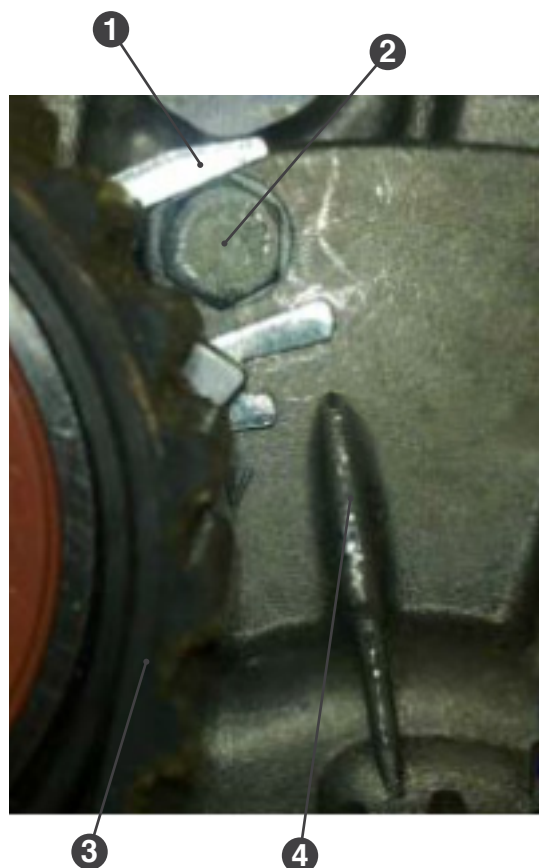
- Severe drive damage caused by wrong Tensioner set up.
- Incorrect positioning of the locating lug will lead to an incorrect Belt tension.
- Incorrect torquing of the Mounting Bolt will result in shearing of the shank, Bolt failure or Tensioner misalignment.

- Visual access is limited when the engine is installed in the vehicle, this often results in incorrect installation.
- The Tensioner can be positioned incorrectly during installation and still give the impression of correct placement.
- Incorrect location of the locating lug will result in deformation, incorrect tension or misalignment.

DIAGRAM	AREA
1	Correctly Located Lug
2	Correct Bolt Head
3	BC0140-1
4	Left positioning Rib

- The Tensioner should sit perfectly against the engine block after the Tensioner Bolt is torqued. There should be no gap between the Tensioner and the engine block, otherwise issues will occur later on.
- **The locating lug must be over the correct Bolt head (located by the left positioning rib).**
