WATER PUMP

MECHANICAL SEAL NOISE

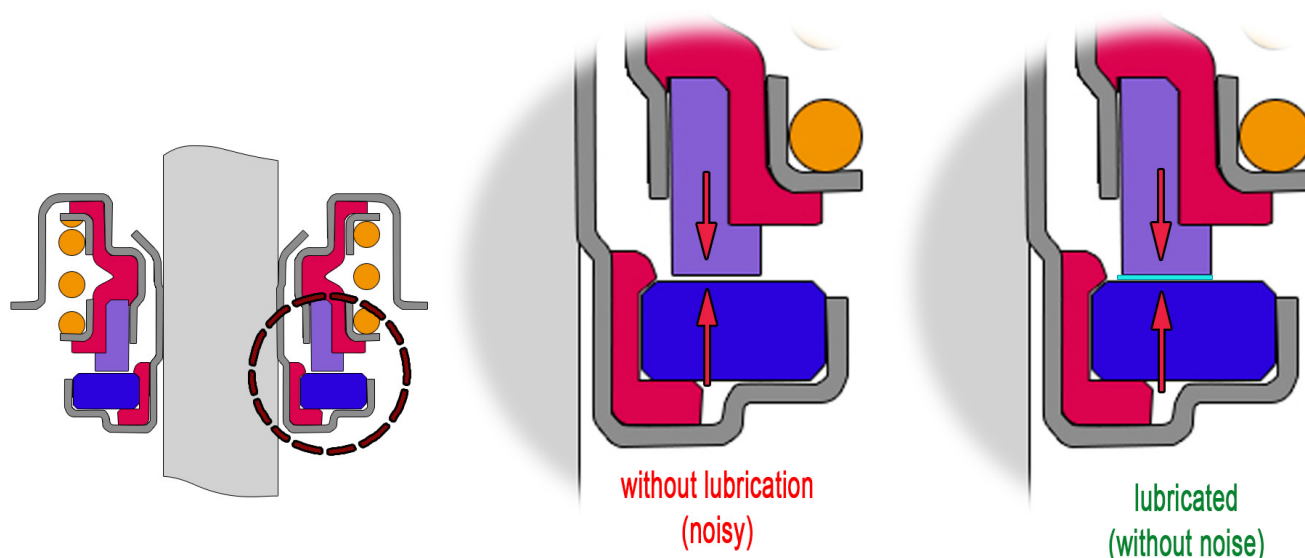
This problem is directly related with the mechanical seal running dry due to lack of lubrication between the slip ring surfaces (see picture below). Irrelevant of the material (ceramic or silica carbide) the seal can run dry. It is more obvious in the silica carbide seal due to its surface properties that support better thermal shock resistance.

Slip ring surfaces require lubrication from the coolant to ensure correct performance, an acceptable life span and to avoid noise.

Good practice during fitment of a water pump is to flush the cooling system to avoid any contamination that could lead to premature failure. Also ensure that the system is bled correctly with no air locks left in the system.
