TC0150FK / TC0151FK

General Advice

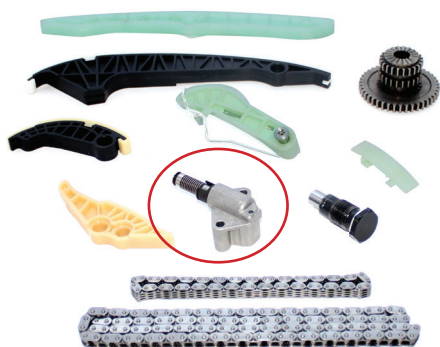
TC0150FK

- Engine damage
- Excessive wear/failure of the chain
- Inconsistent tension due to changing oil volumes
- Blockage of chain lubrication holes

- Excessive oil consumption
- Internal engine contamination
- Carbonization blocking oilways through the cylinder head

- Inspect the camshaft bearings for signs of wear or scoring, this indicates poor lubrication
- Ensure the oil feed holes on the front face of the gasket are not blocked
- Replacement of the oil pump is recommended whilst changing the timing chain kit
- An engine flush is recommended alongside the installation of these parts
- Ensure that an adequate oil level is maintained at all times

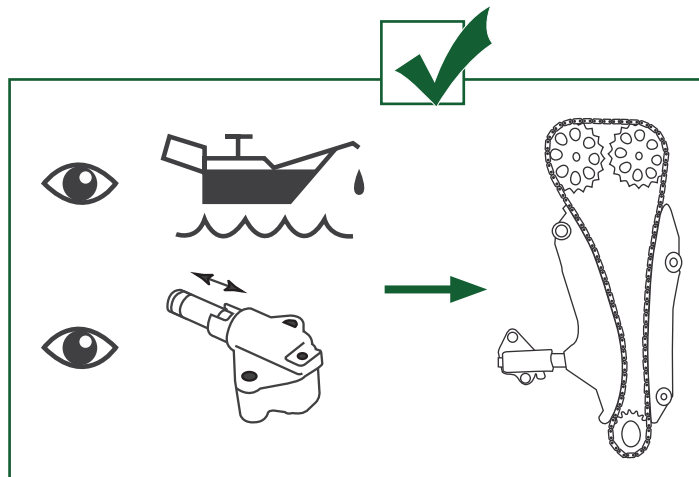
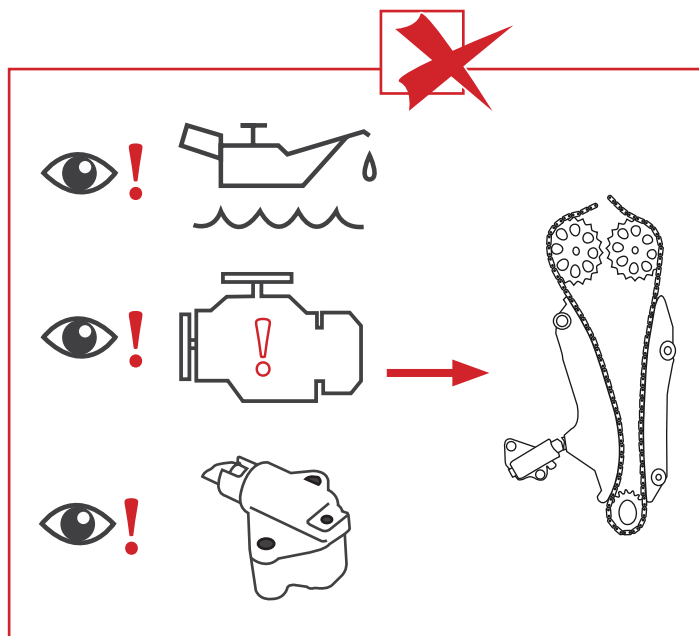
FAILURE TO MAINTAIN AN ADEQUATE LEVEL OF OIL MAY LEAD TO PREMATURE FAILURE OF THE TENSIONER. THIS CAN CAUSE DAMAGE TO THE ENGINE

IT IS RECOMMENDED THAT OIL CONDITION IS CHECKED BEFORE INSTALLATION OF NEW COMPONENTS. CLEAN OIL IS RECOMMENDED BEFORE THE INSTALLATION
