VALVE BREAKAGE

Renault 1.4 L & 1.6 L 16 Valve Engines

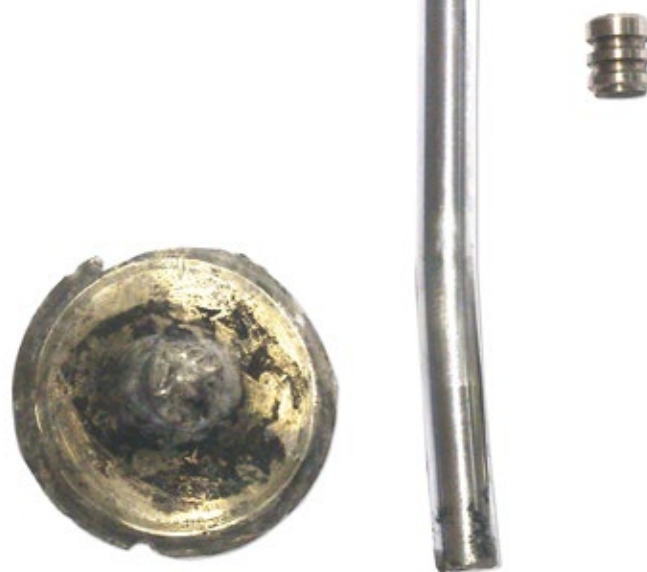
Failure commonly occurs at the lower sections of the Collet groove due to misalignment of the linear Valve functions.

- Check intake and exhaust pathways to liquid galleries for cracks. We strongly recommend all the Guides and Valves are replaced.
- Make sure the Hydraulic Lifter pathways are free from damage or wear. We strongly recommend all the Hydraulic Lifters are replaced.
- If re-using the Valve Collets, springs and spring plates confirm there is no wear evident.
- Use clean oil during assembly to ensure all the contact surfaces are free from contamination.
- **DO NOT** tap the Valve Stem with a hammer to gain the correct location of the Collets (in modern engines especially) as this can create micro-fractures at the lower sections of the Collet groove resulting in premature failure of the Valve.
