# OIL PUMP QUALITY STATEMENT

# BGA'S OIL PUMP QUALITY TESTING

Example: Oil Pump Movement Issue, LP0802K.

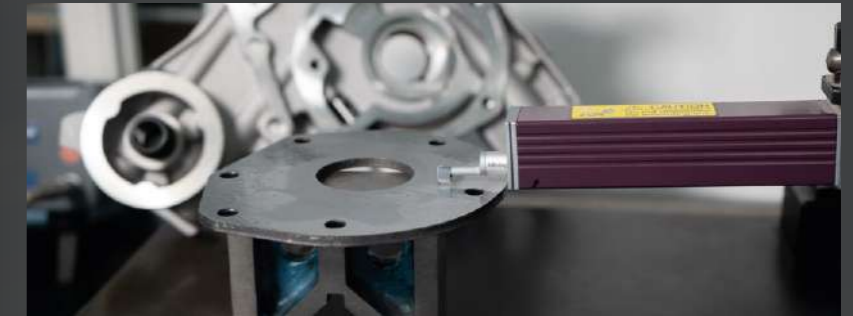
### Surface finish of wear plate.

Surface finish is critical to the operation of the pump to prevent excessive wear between stationary components such as the wear plate and the rotor itself.

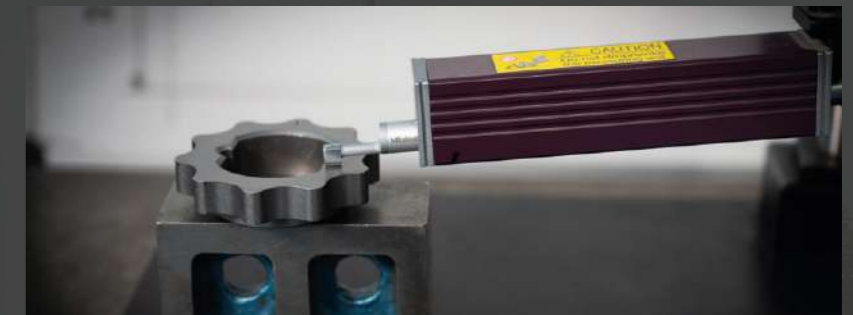
### Surface finish of rotor.

All critical surfaces are measured for both hardness and surface finish compared with the OE specification.

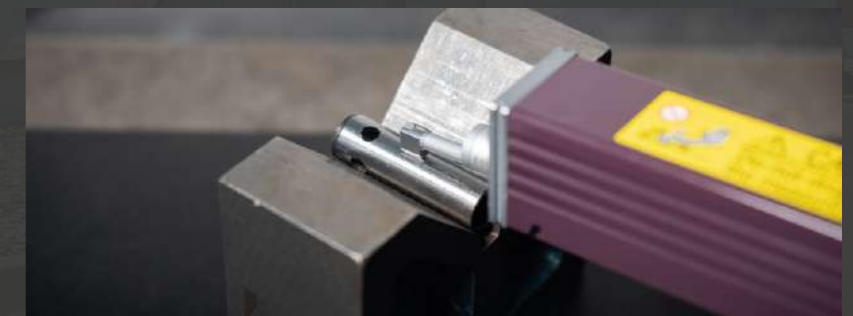
### Surface finish of relief valve.

All critical dimensions are measured using our CMM and compared with the OEM sample.

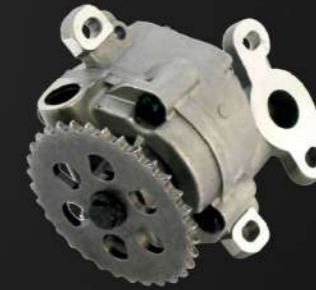
## CHAIN DRIVEN:

With more modern vehicles being equipped with Timing Chains, the Oil Pump has followed this trend with the drive of a chain system.

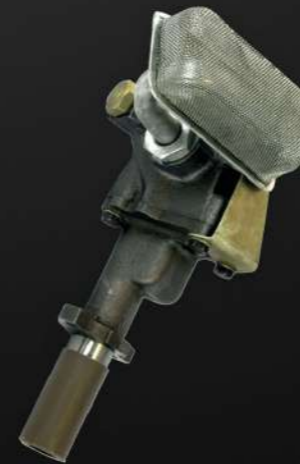
## SHAFT DRIVEN:

Incorporating a drive shaft, this type of pump is usually driven from a crankshaft or Intermediary Shaft. A spline or slot fitment is usually found on the end of the shaft.

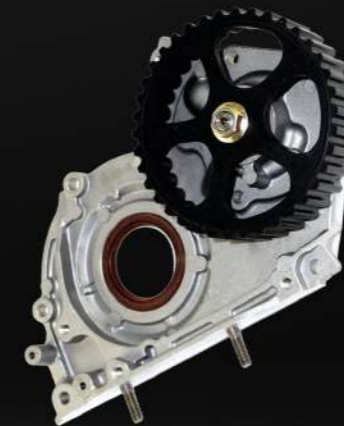
## BELT DRIVEN

Equipped with a pulley instead of a sprocket, this design is driven by a rubber belt, much like a water or vacuum pump.

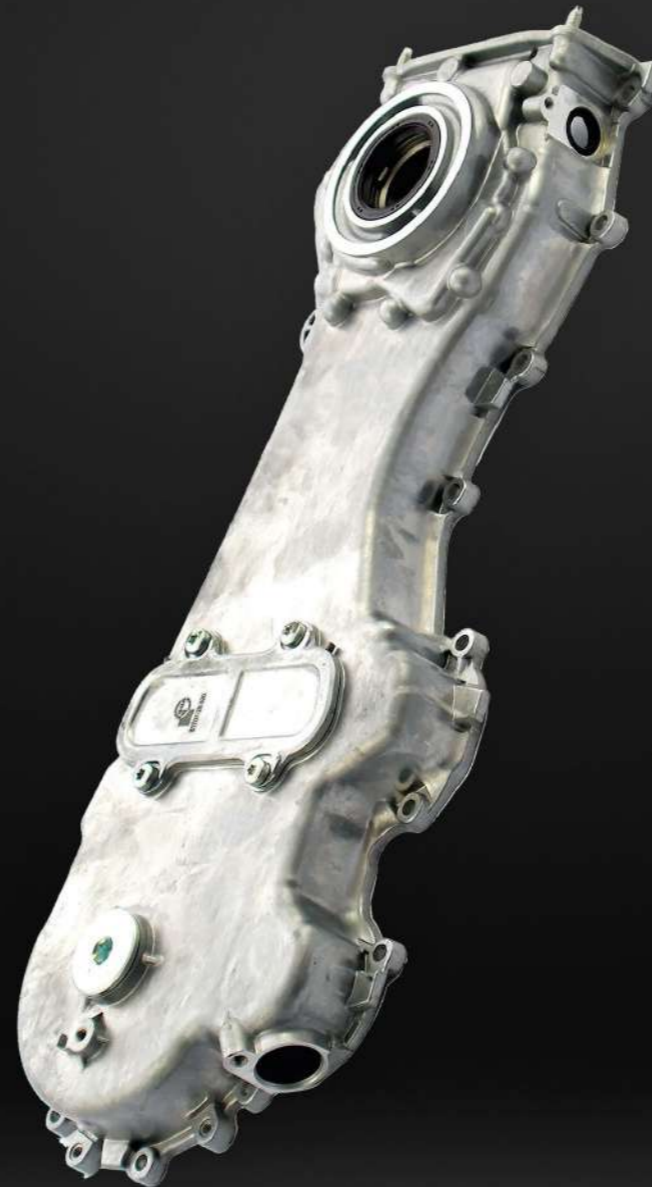
**BGA have modified and improved the LP0802K to overcome movement issues.**

The Rotor and Drive Pulley contact areas have been increased by 72% which reduces the movement tolerance to  $0.5 > 1^\circ$ . The Pulley has been secured and correctly torqued negating the need for removal during installation.

A design flaw in the OE Pump led to insufficient contact area between the drive shaft and the rotor, allowing  $3-5^\circ$  of movement between the shaft and the rotor. BGA reengineered the shaft to increase this surface area by 72%.

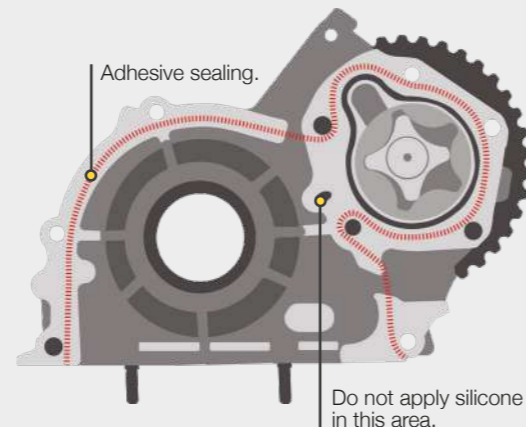
Do not apply silicone in this area.

- During Timing Belt replacement, thoroughly examine the Oil Pump's rotor shaft, rotor drive contact face and behind the drive pulley for wear. If evident, replace all.
- Never replace an Oil Pump without a new Pulley and locking nut.
- Do not tighten beyond 25nm or 18.5 ft-lbf.
- Removing the pulley is not required during installation of the BGA Pump because it could damage the rotor seal.
- Apply adhesive sealing compound as shown by the dotted area.

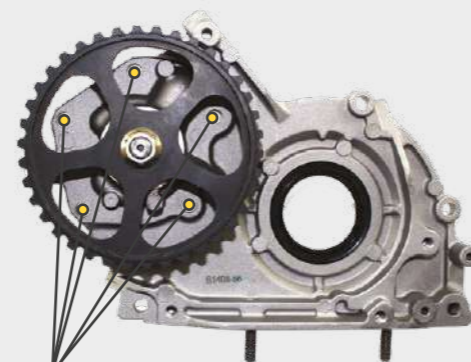
The bolt holes are accessible; Pulley removal is not necessary.
