C09611

Oil Separator for VW 1.5 TSi engines

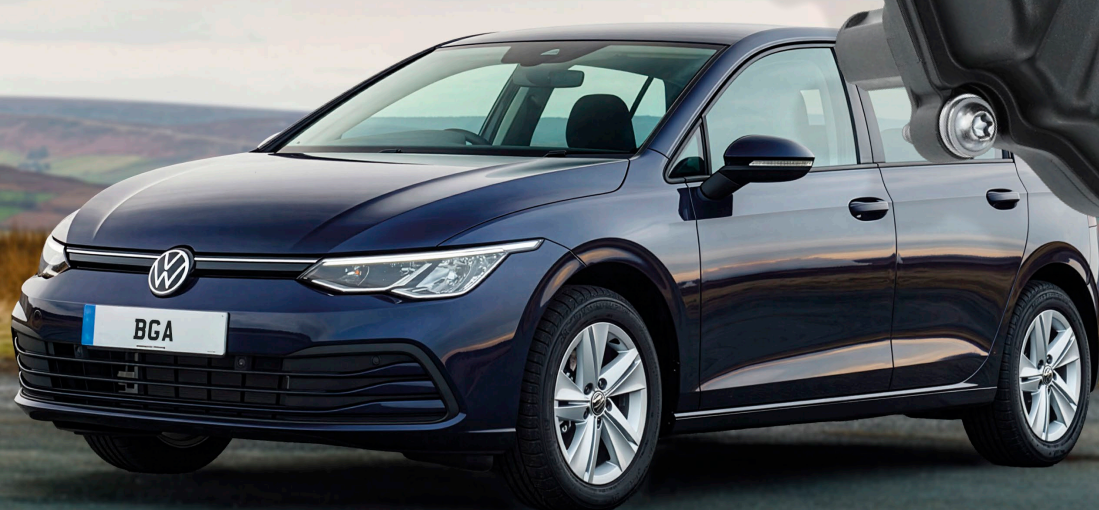
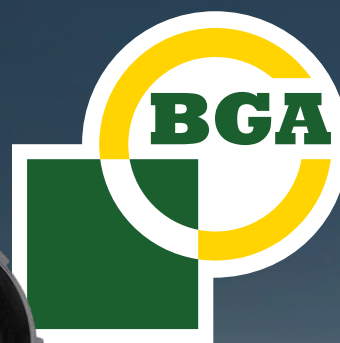
The PCV valve and the diaphragm are known to fail which means unmetered air is allowed into the intake, disrupting the fuel-air mixture and causing a loss of power, a hissing sound or the check engine light comes on. As this is a common failure, BGA have launched the entire separator to offer garages the complete solution.
