TECHNICAL BULLETIN

INSPECTION PRIOR TO INSTALLATION

TB-TC2335K-070624

TC2335K

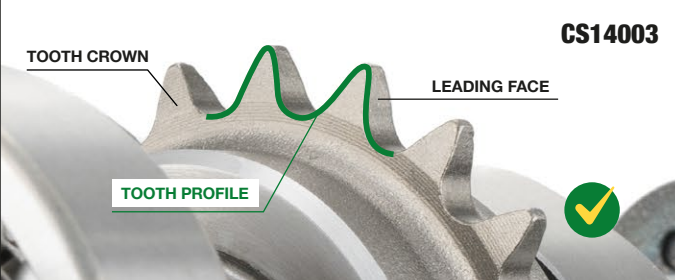
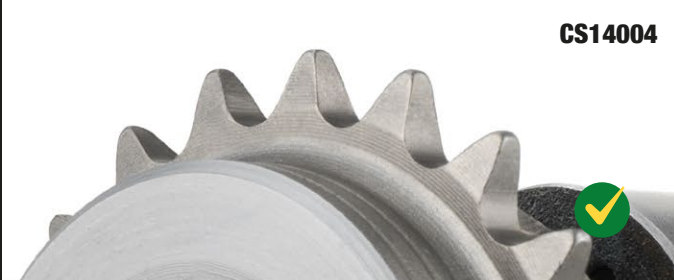
| | INLET CAMSHAFT (WITH BEARING) | EXHAUST (WITHOUT BEARING) |
| NEW TOOTH PROFILE | <p>CS14003</p> | <p>CS14004</p> |

| | INLET CAMSHAFT (WITH BEARING) | EXHAUST (WITHOUT BEARING) |
|---|---|---|
| IMPORTANT | <ul style="list-style-type: none"> Replace camshafts if signs of wear are evident. Ersetzen Sie die Nockenwelle, wenn Anzeichen von Verschleiß erkennbar sind. Remplacez l'arbre à cames si des signes d'usure sont évidents. | <ul style="list-style-type: none"> Sostituire l'albero a camme se sono evidenti segni di usura. Reemplace el árbol de levas si hay signos evidentes de desgaste. Замените распределительный вал, если очевидны признаки износа. |

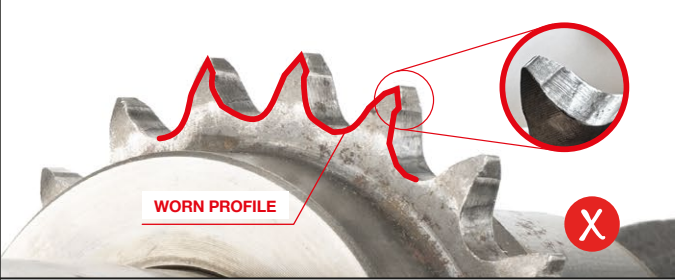
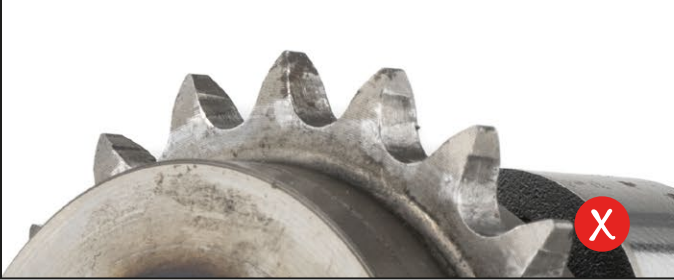
| | INLET CAMSHAFT (WITH BEARING) | EXHAUST (WITHOUT BEARING) |
|---|---|---|
| WORN TOOTH PROFILE | <p>WORN PROFILE</p> | |
