THE REASON

RC0397/RC7369

Correct gasket for fitting

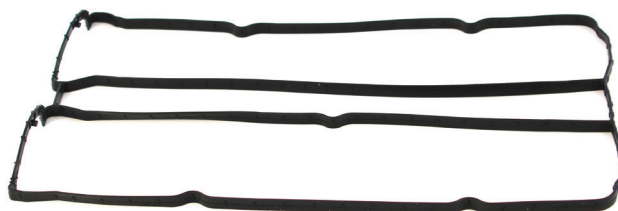
RC7369

- For **Plastic** valve cover:

- Tightening procedure for both versions of gasket
 - 1) 3 Nm
 - 2) 10Nm

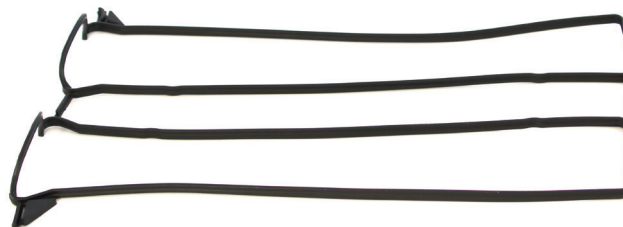
RC0397

- For **Aluminium** valve cover
