THE PROBLEM:

Modern engines including the PSA DV5 are fitted with EGR and DPF to fall in line with Euro emissions control legislation. This provides an improvement in MPG and lowers emissions but has a negative impact on the engine.

THE SOLUTION:

Identifying your vehicle, 7mm or 8mm Timing setup?

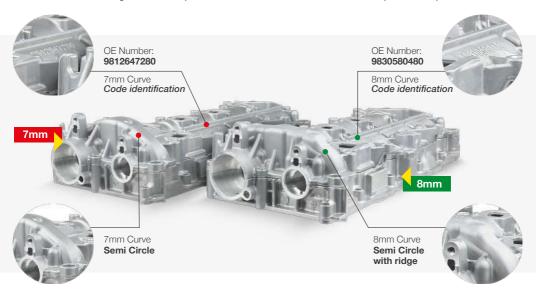
It is possible to identify which Timing Setup you have fitted to your vehicle without removing the cover to inspect the chain and intergraded cam sprockets. Cam Carrier has been modified to accommodate the increase size of the timing setup.

Original covers will also have different OE numbers on the housing.

Once you have the Cam Carrier removed the difference between the 7mm and 8mm Timing Setup can be identified by the number of links of the timing chain or the number of teeth on the integrated camshaft sprockets.
