TECHNICAL BULLETIN

INSPECTION PRIOR TO INSTALLATION

TB-TC2312K-280324

INLET CAMSHAFT (WITH BEARING)	EXHAUST (WITHOUT BEARING)
NEW TOOTH PROFILE

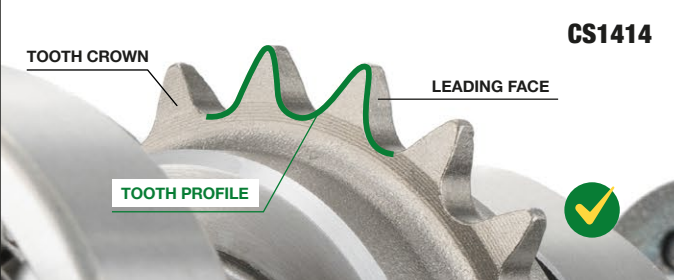
<p>TOOTH CROWN</p> <p>LEADING FACE</p> <p>TOOTH PROFILE</p> <p>CS1414</p> <p>✓</p>

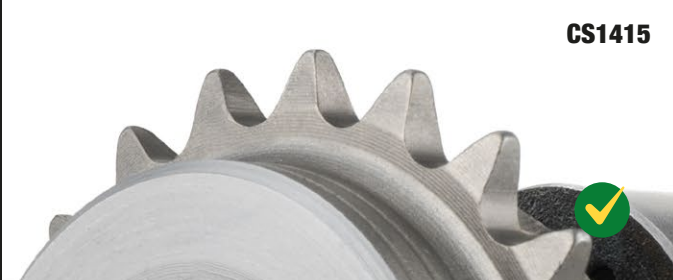
<p>CS1415</p> <p>✓</p>
WORN TOOTH PROFILE

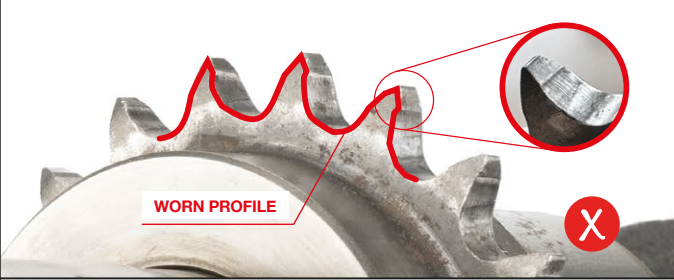
<p>WORN PROFILE</p> <p>✗</p>

Replace camshafts if signs of wear are evident.</p> <p>

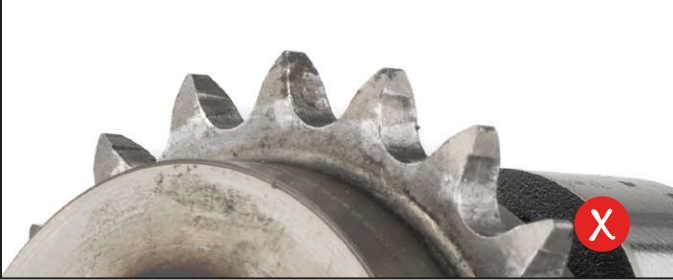
<p>✗</p>
IMPORTANT	<p>
